Field thermovision study of external enclosure for multi-storey residential building under climatic conditions of Northern Kazakhstan

Abstract. An in-place thermovision study was carried out in a multi-apartment apartment building of high comfort in a cold period of the year, located in the Northern part of the Republic of Kazakhstan in the work. The study result showed the presence of significant problems on thermal protection at the edge and inner corner fences where the temperature difference between the inner surface of an enclosure and the internal temperature was 6.4 - 19.4°C. An analysis of thermograms of window joints in living rooms also showed a significant temperature drop from -9.3°C to 18°C, where total vulnerable area was up to 10%. Thermograms of window-sill joints of living rooms also showed a temperature drop to -21.1 °C with an area of 15.7 %. The temperature on a reinforced concrete column's inner surface showed a value of 6.5 °C, which is typical for an area of 34.8 %. An analysis of outside and inside temperatures showed that as the temperature drops from -7 °C to -23 °C during the day, the inside temperature of the room remains relatively stable at 25.3 - 26.

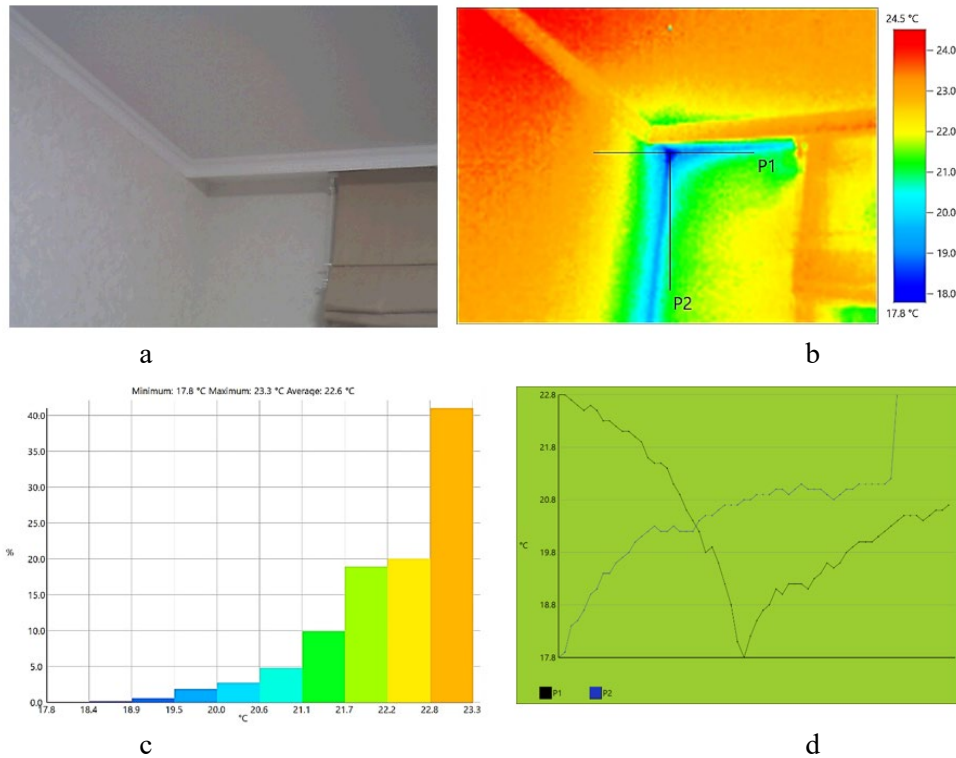
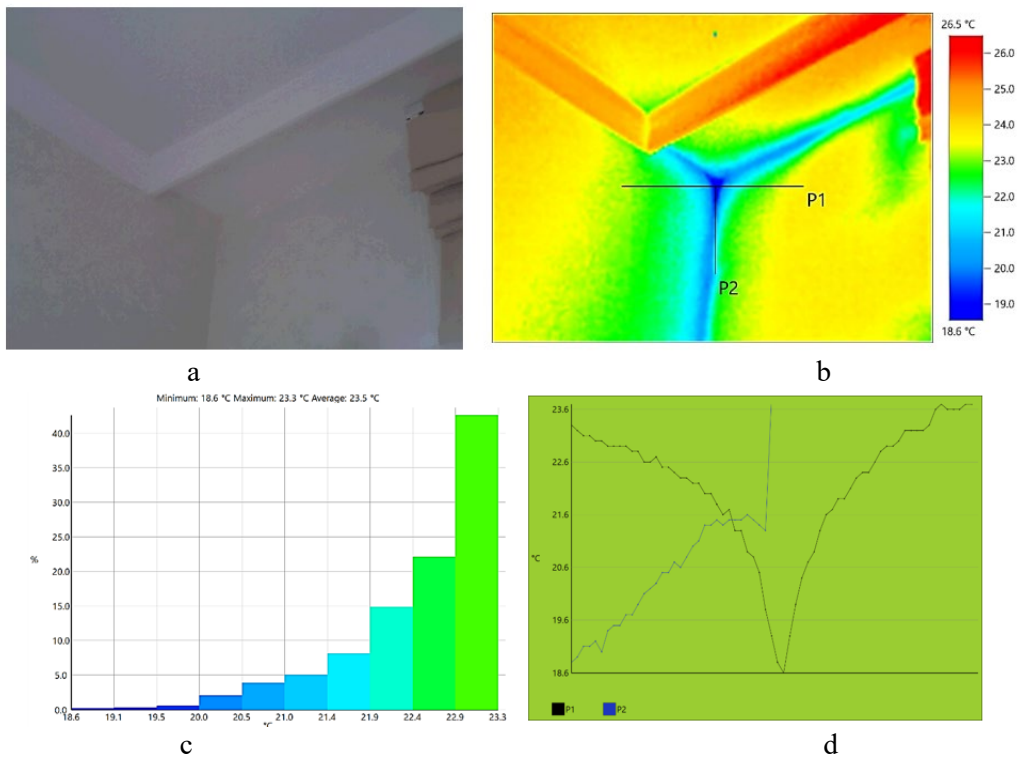
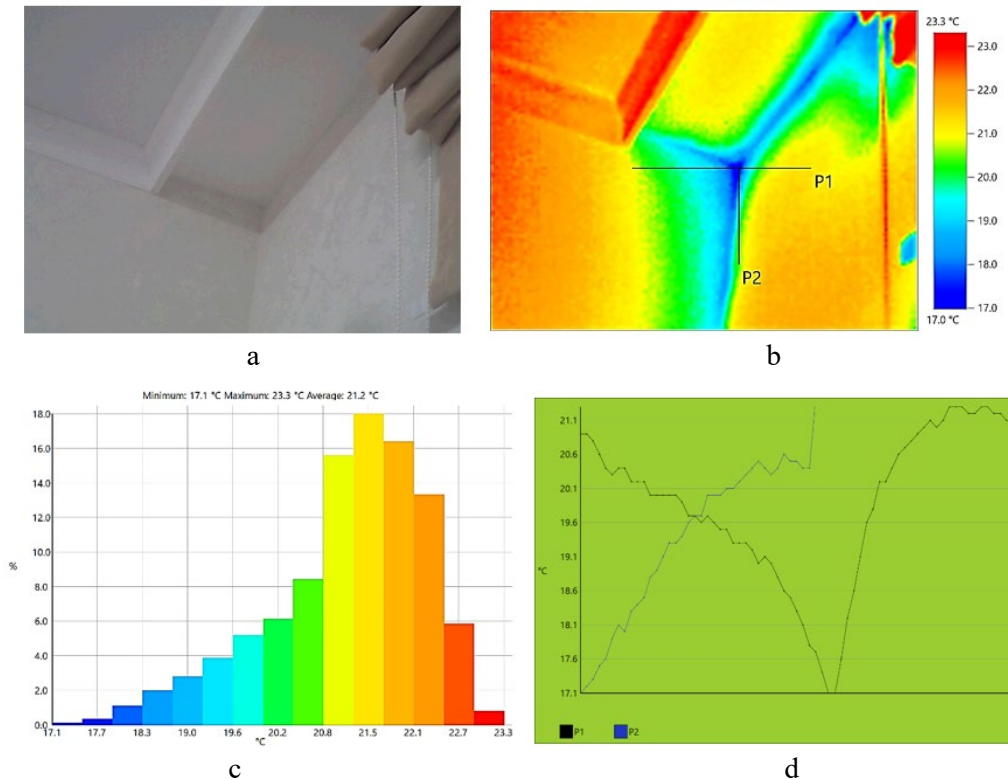
Fig. 6. A thermogram of the left upper vertical corner joint of room No.1 between 9:00 and 10:00h: a – in-place photo; b – thermogram; c – diagram of the area covered by the respective temperature; d – diagram of horizontal (P1) and vertical (P2) temperature values relative to Fig. b.

Fig. 7. A thermogram of the left upper vertical corner joint of room No.1 between 14:00 and 15:00h: a – in-place photo; b – thermogram; c – diagram of the area covered by the respective temperature; d – diagram of horizontal (P1) and vertical (P2) temperature values relative to Fig. b.

Fig. 8. A thermogram of the left upper vertical corner joint of room No.1 between 21:00 and 22:00h: a – in-place photo; b – thermogram; c – diagram of the area covered by the respective temperature; d – diagram of horizontal (P1) and vertical (P2) temperature values relative to Fig. b.

An analysis of the thermograms in the upper left corner on Figures 6-8 shows that the temperature difference between the enclosure surface temperature and the internal air temperature was $7.2 - 9.0^{\circ}\text{C}$ dependent on the survey time (Table 4). Furthermore, the enclosure surface temperature shows a positive value of $17.1 - 18.6^{\circ}\text{C}$ due to an increase of heater output, which leads to excessive overconsumption of heat energy, as well as an increase of internal room temperature (Table 4), which is contrary to the standard GOST 30494. At that, if heater output is reduced, the internal surface temperature of external enclosure will decrease, that indicates insufficient thermal protection of the enclosure in the survey area, Fig. 6 – 8. Besides, the indoor humidity indicated in Table 4 in all cases of the survey shows a lower than optimal value, which also contradicts the specified standard GOST 30494.

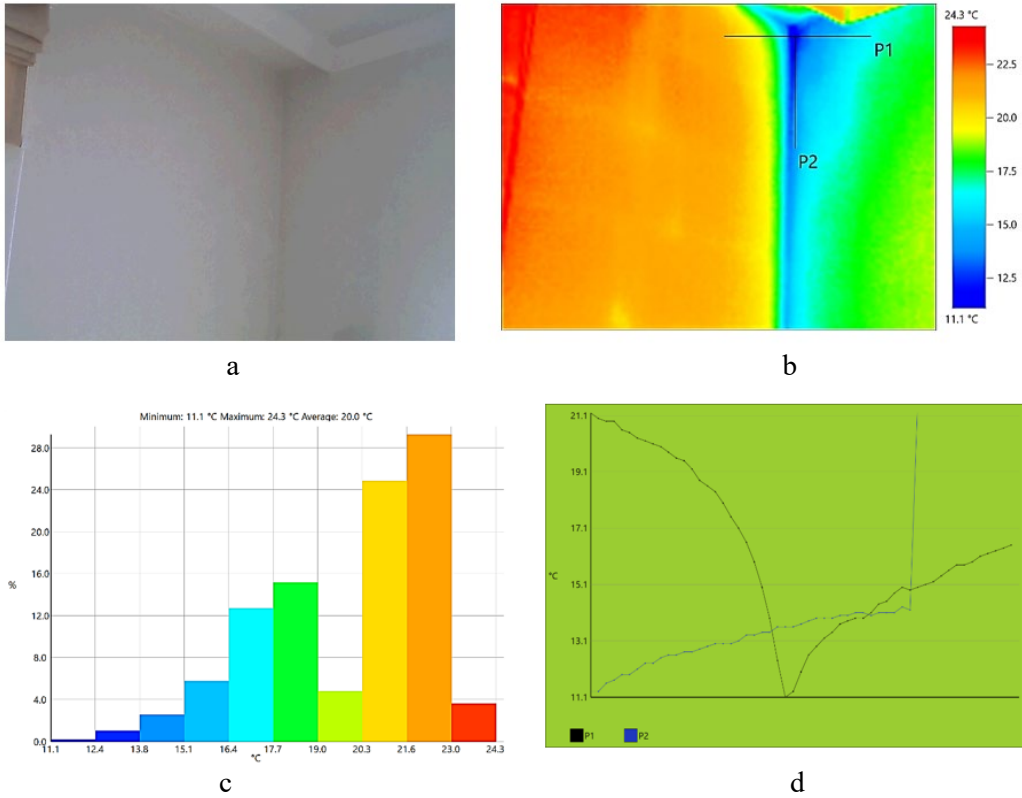
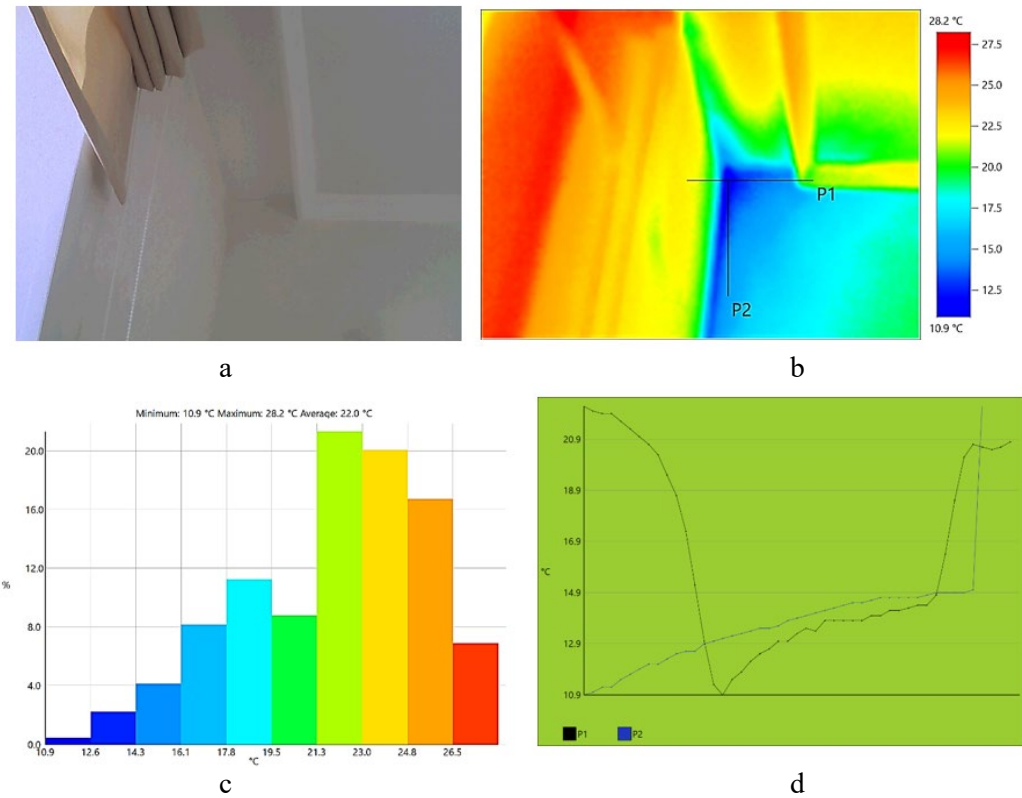
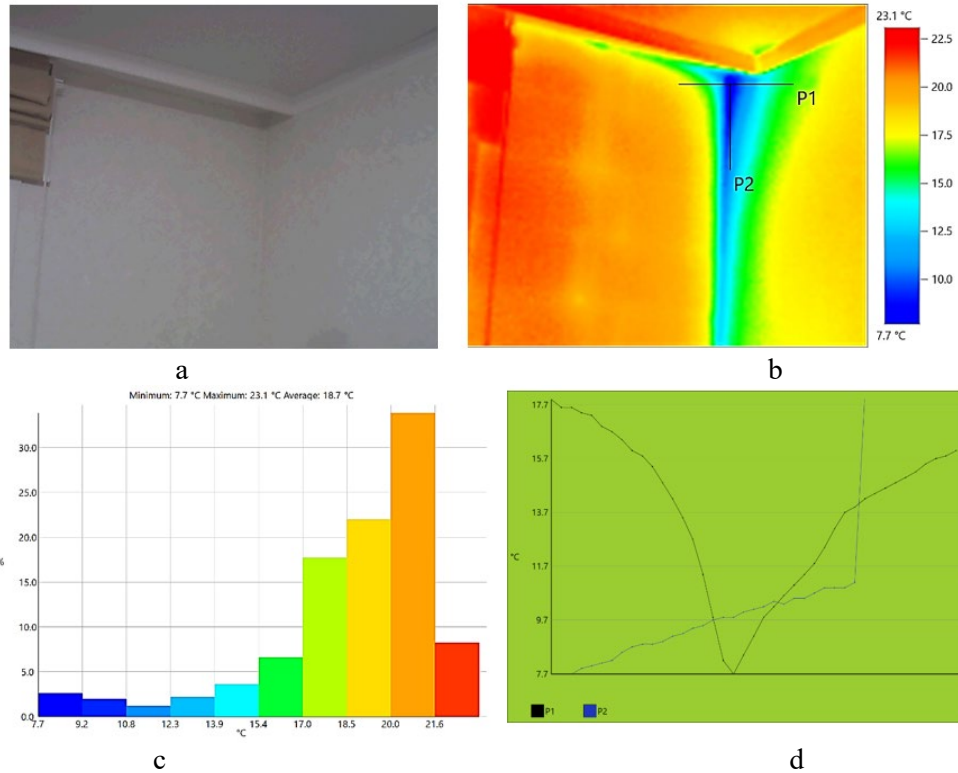
Fig. 9. A thermogram of the right upper vertical corner joint of room No.1 between 09:00 and 10:00h: a – in-place photo; b – thermogram; c – diagram of the area covered by the respective temperature; d – diagram of horizontal (P1) and vertical (P2) temperature values relative to Fig. b.

Fig. 10. A thermogram of the right upper vertical corner joint of room No.1 between 14:00 and 15:00h: a – in-place photo; b – thermogram; c – diagram of the area covered by the respective temperature; d – diagram of horizontal (P1) and vertical (P2) temperature values relative to Fig. b.

Fig. 11. A thermogram of the right upper vertical corner joint of room No.1 between 21:00 and 22:00h: a – in-place photo; b – thermogram; c – diagram of the area covered by the respective temperature; d – diagram of horizontal (P1) and vertical (P2) temperature values relative to Fig. b.

An analysis of the thermograms in the right left corner of a room No.1 showed (Figure 9-11) that thermal protection relatively to the considered left corner (Figure 6-8) turned out to be significantly lower. Thus, the temperature drop between the internal surface of external enclosure and the internal air temperature was 14.2 - 18.4 °C (Figure 9-11), which also fails to meet the requirements SP RK 2.04-107-2022 and indicates a problem of thermal energy overconsumption at the cost of maintaining the required indoor temperature. But excessive increase of heater outputs leads to the issue of indoor overheating (Table 4), but it does not resolve the issue of thermal protection of external enclosure.

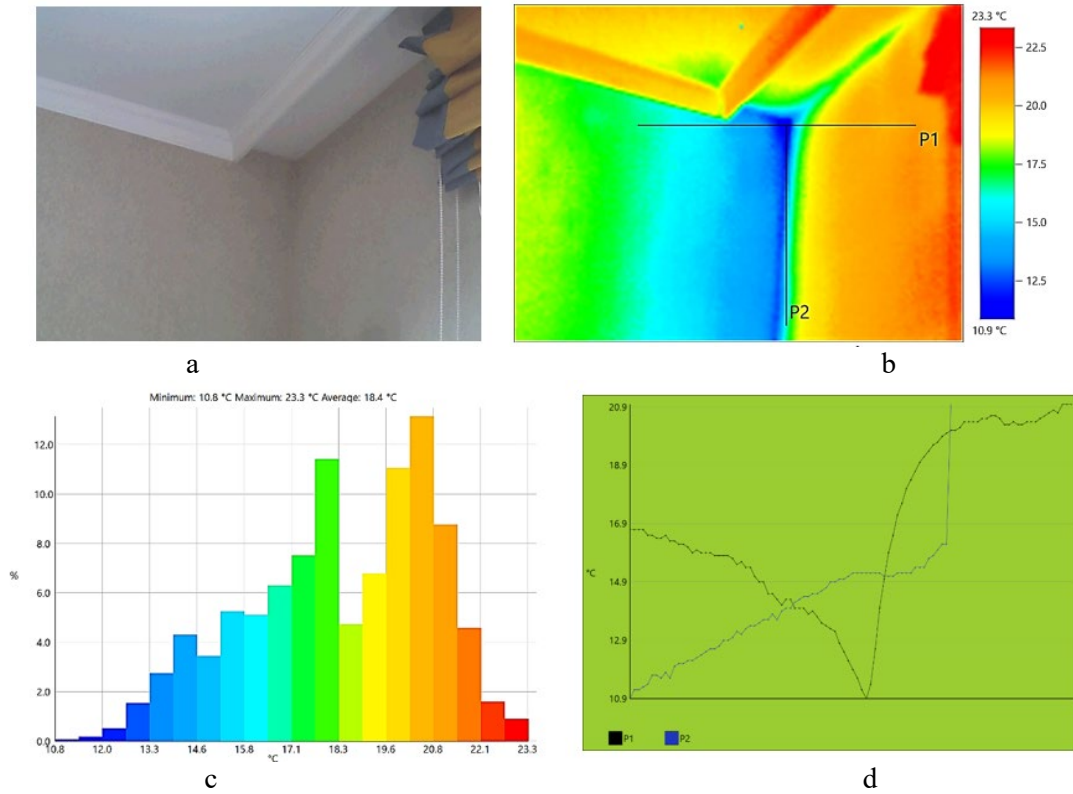
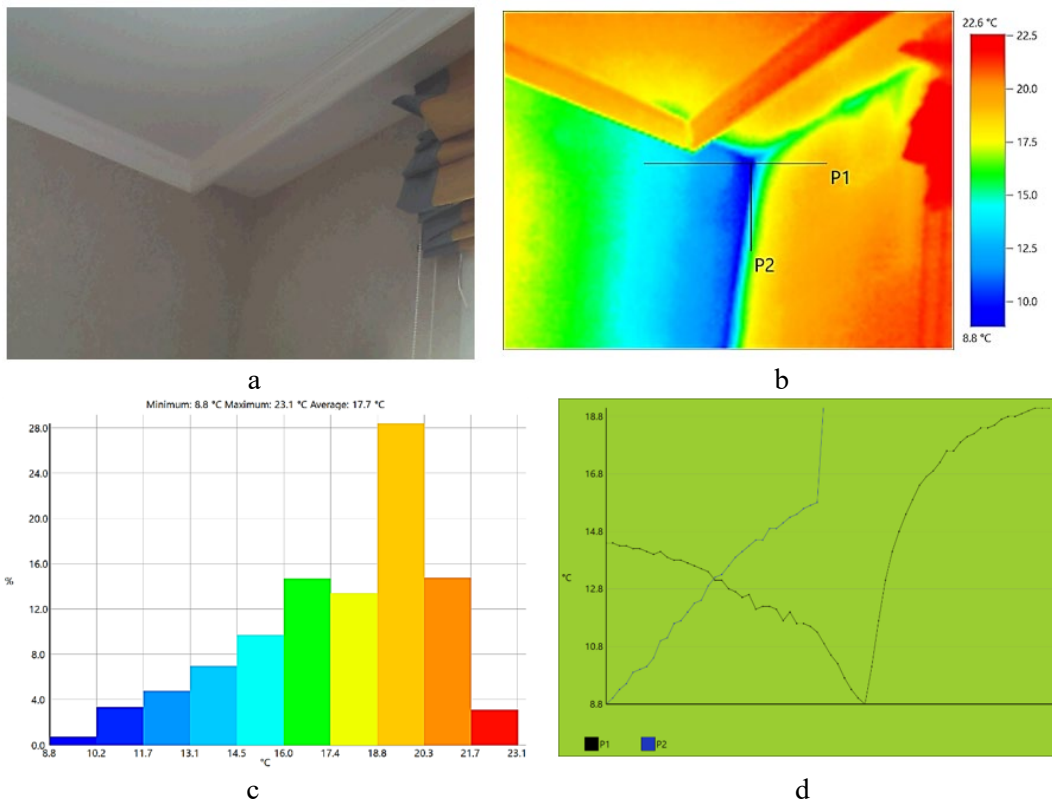
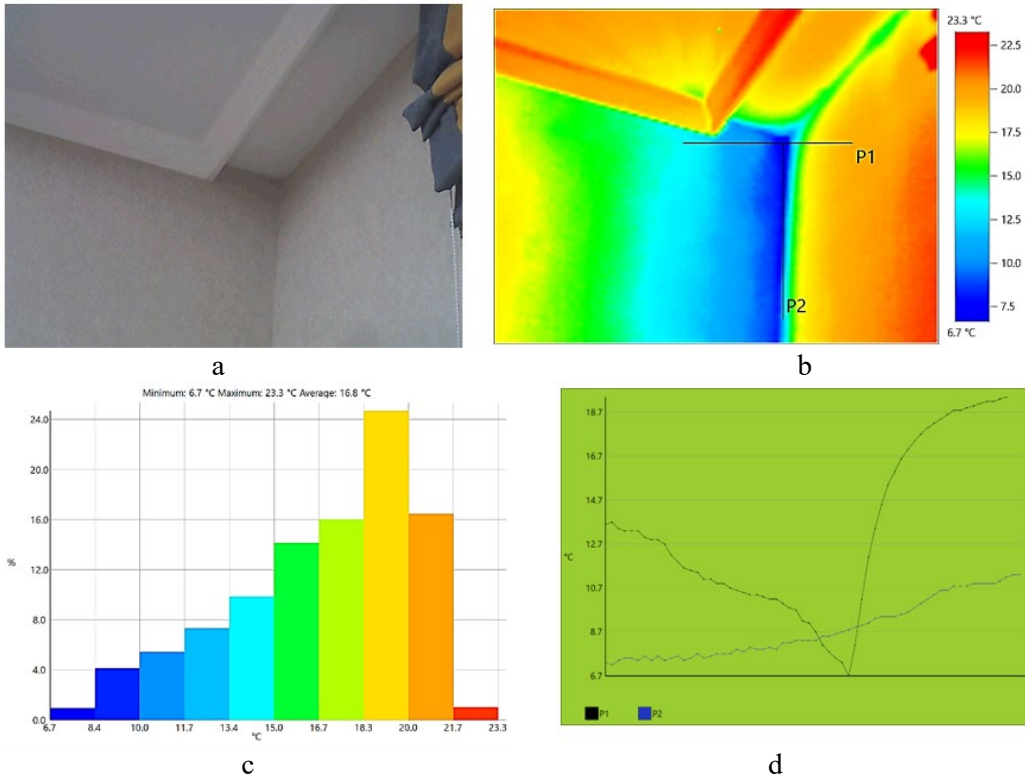
Fig. 12. A thermogram of the left upper vertical corner joint of room No.2 between 9:00 and 10:00h: a – in-place photo; b – thermogram; c – diagram of the area covered by the respective temperature; d – diagram of horizontal (P1) and vertical (P2) temperature values relative to Fig. b.

Fig. 13. A thermogram of the left upper vertical corner joint of room No.2 between 14:00 and 15:00h: a – in-place photo; b – thermogram; c – diagram of the area covered by the respective temperature; d – diagram of horizontal (P1) and vertical (P2) temperature values relative to Fig. b

Fig. 14. A thermogram of the left upper vertical corner joint of room No.2 between 21:00 and 22:00h: a – in-place photo; b – thermogram; c – diagram of the area covered by the respective temperature; d – diagram of horizontal (P1) and vertical (P2) temperature values relative to Fig. b.

Thermograms of the left vertical corner joint in Room No.2 indicate an excessive temperature drop between internal enclosure surface and internal air temperature, where the value of drop was 14.5 - 19.4 °C. (Fig. 12-14), this indicates non-compliance with the standard SP RK 2.04-107-2022, the implications of which influence excessive thermal energy consumption to maintain appropriate temperature (Table 4). An analysis of the right vertical corner joint in this room showed a slight deviation, which is equal to an average of 6.4 %, Fig. 15-17.

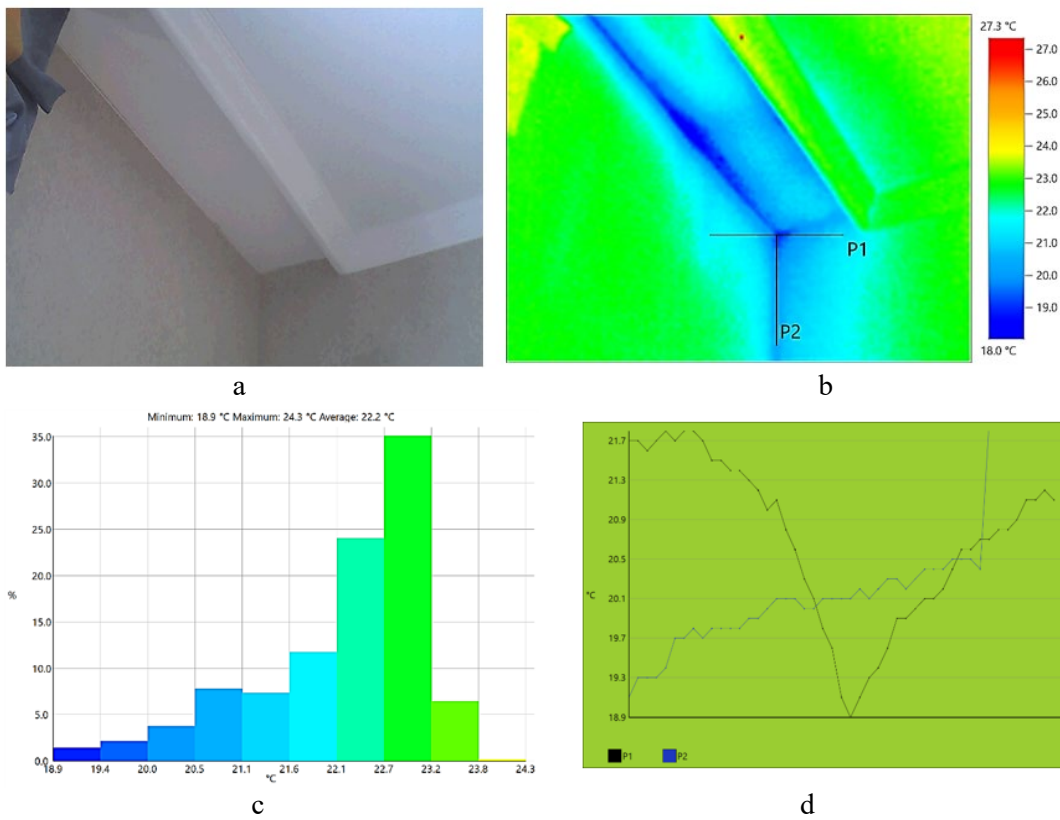
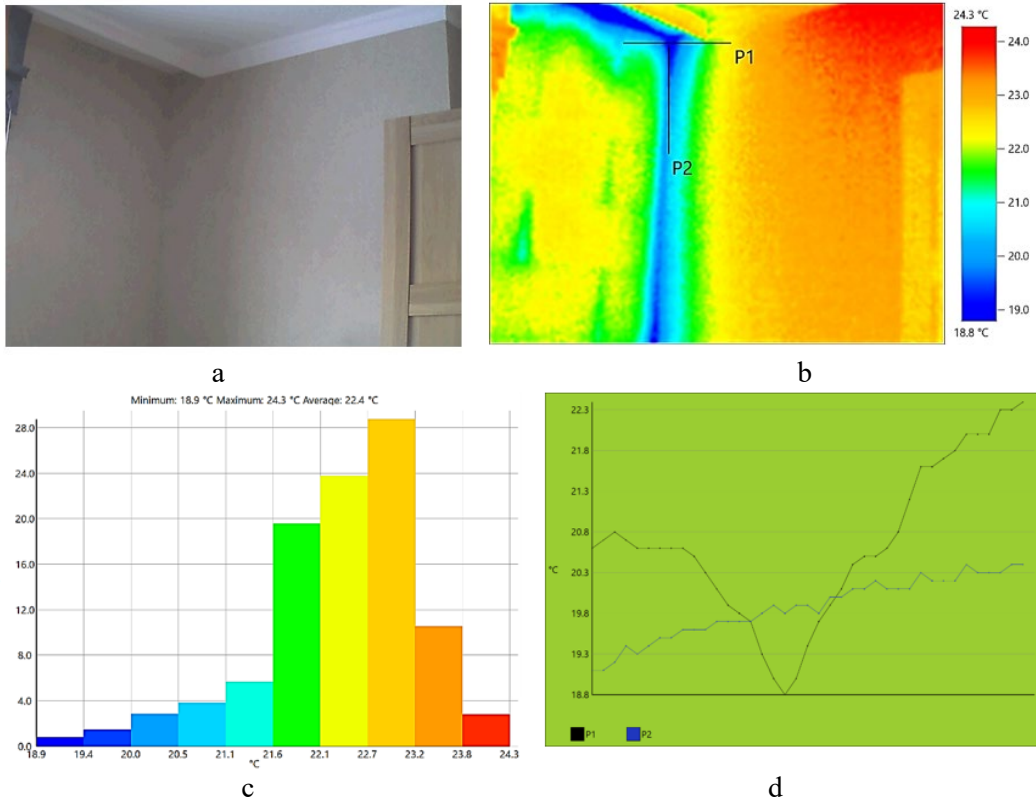
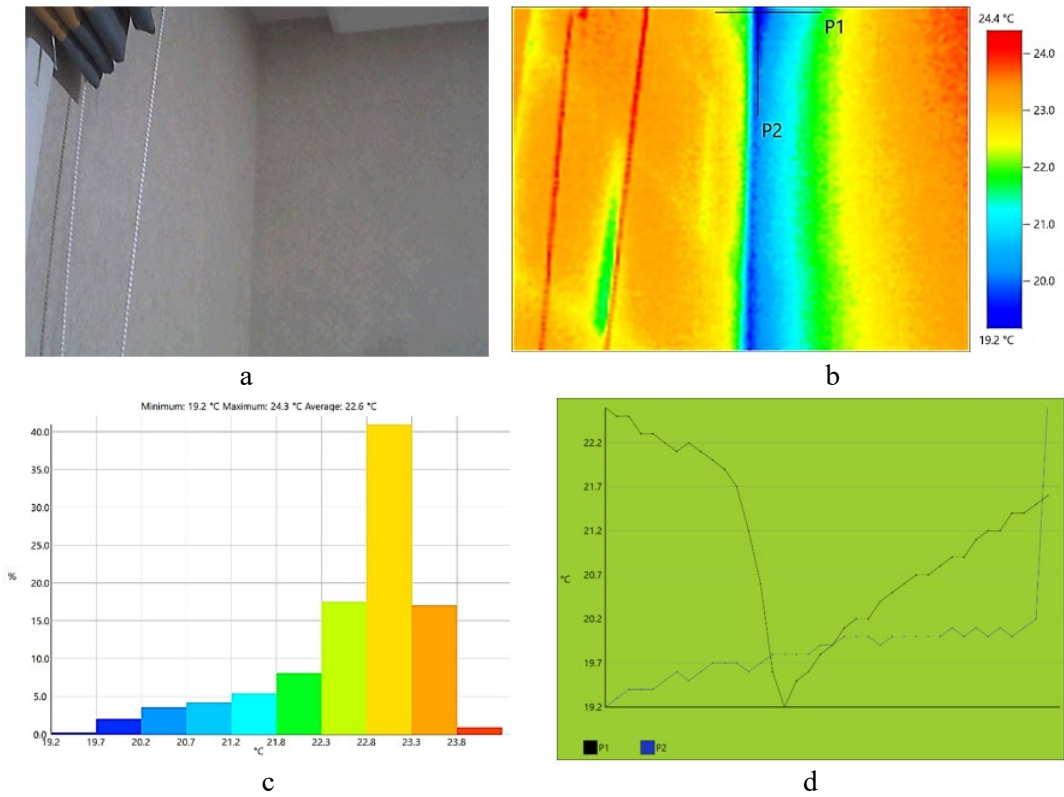
Fig. 15. A thermogram of the right upper vertical corner joint of room No.2 between 9:00 and 10:00h: a – in-place photo; b – thermogram; c – diagram of the area covered by the respective temperature; d – diagram of horizontal (P1) and vertical (P2) temperature values relative to Fig. b.

Fig. 16. A thermogram of the right upper vertical corner joint of room No.2 between 14:00 and 15:00h: a – in-place photo; b – thermogram; c – diagram of the area covered by the respective temperature; d – diagram of horizontal (P1) and vertical (P2) temperature values relative to Fig. b.

Fig. 17. A thermogram of the right upper vertical corner joint of room No.2 between 21:00 and 22:00h: a – in-place photo; b – thermogram; c – diagram of the area covered by the respective temperature; d – diagram of horizontal (P1) and vertical (P2) temperature values relative to Fig. b.

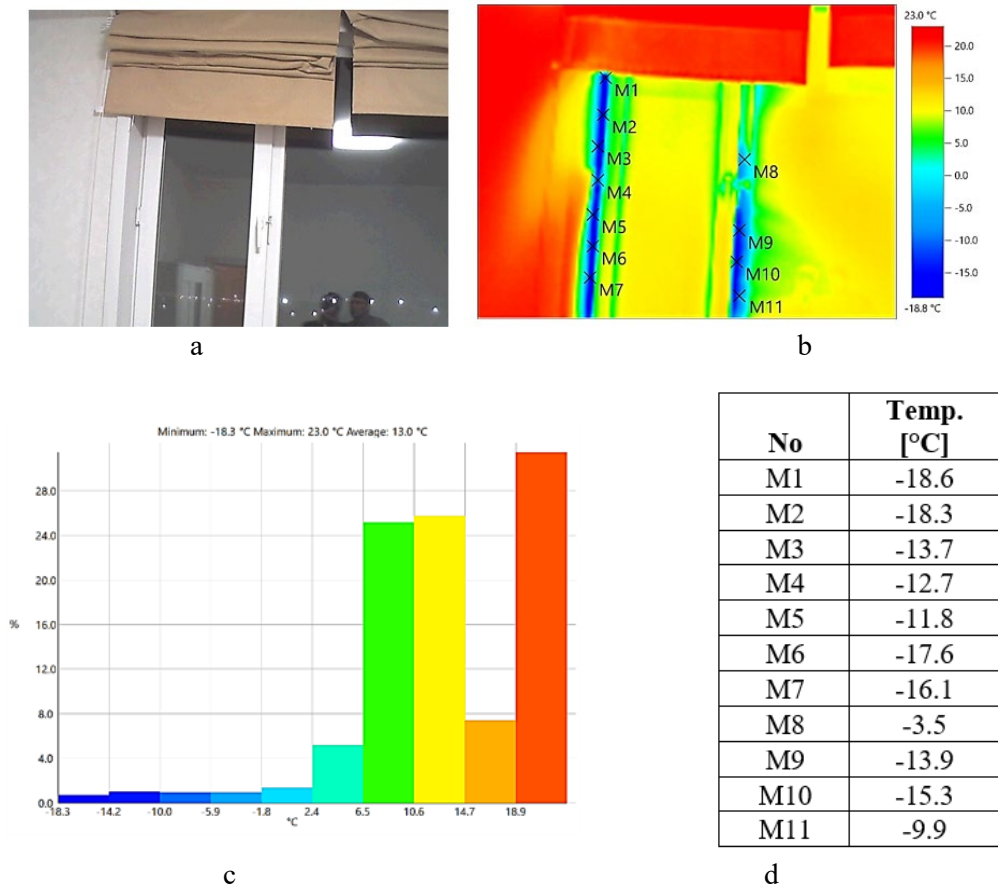
Fig. 18. A thermogram of the left vertical joint of external window in room No.1: a – in-place photo; b – thermogram with characteristic points; c – diagram of the area covered by the respective temperature; d – table of point values on the enclosure of Fig. b.

Based on thermovision survey of vulnerable places in residential premises (Fig. 18-22) it was determined that the left vertical joint of external window in room No.1 (Fig.18a) does not comply with the standards SP RK 2.04-107-2022, as temperature at the external wall and frame of the translucent aperture showed a significant temperature drop (Fig.18 d) with maximum temperature of -18 °C at the point M1 (Figure 17 b). All in all, the zone of unfavorable temperature of the vertical opening considered (Fig.17 a) is 10% (Fig. 18 c) of the total area of Fig. 18 (a, b). Survey of the window sill in this room showed (Figure 19 a) that it also does not comply with the thermal protection standards SP RK 2.04-107-2022. As there is a significant temperature drop (Fig.19 d), where minimum temperature on the window sill was -21.1 °C, which is typical to point M9 (Fig. 19 b). The zone of unfavorable of window sill temperature is 15.7% (Figure 19 c) of the total area, Survey of the window sill in this room showed (Fig. 19 a) that it also does not comply with the thermal protection standards. As there is a significant temperature drop (Fig.19 d), where minimum temperature on the window sill was -21.1 °C, which is typical to point M9 (Fig. 19 b). The zone of unfavorable of window sill temperature is 15.7% (Fig. 19 c) of the total area, Fig. 19 (a, b).

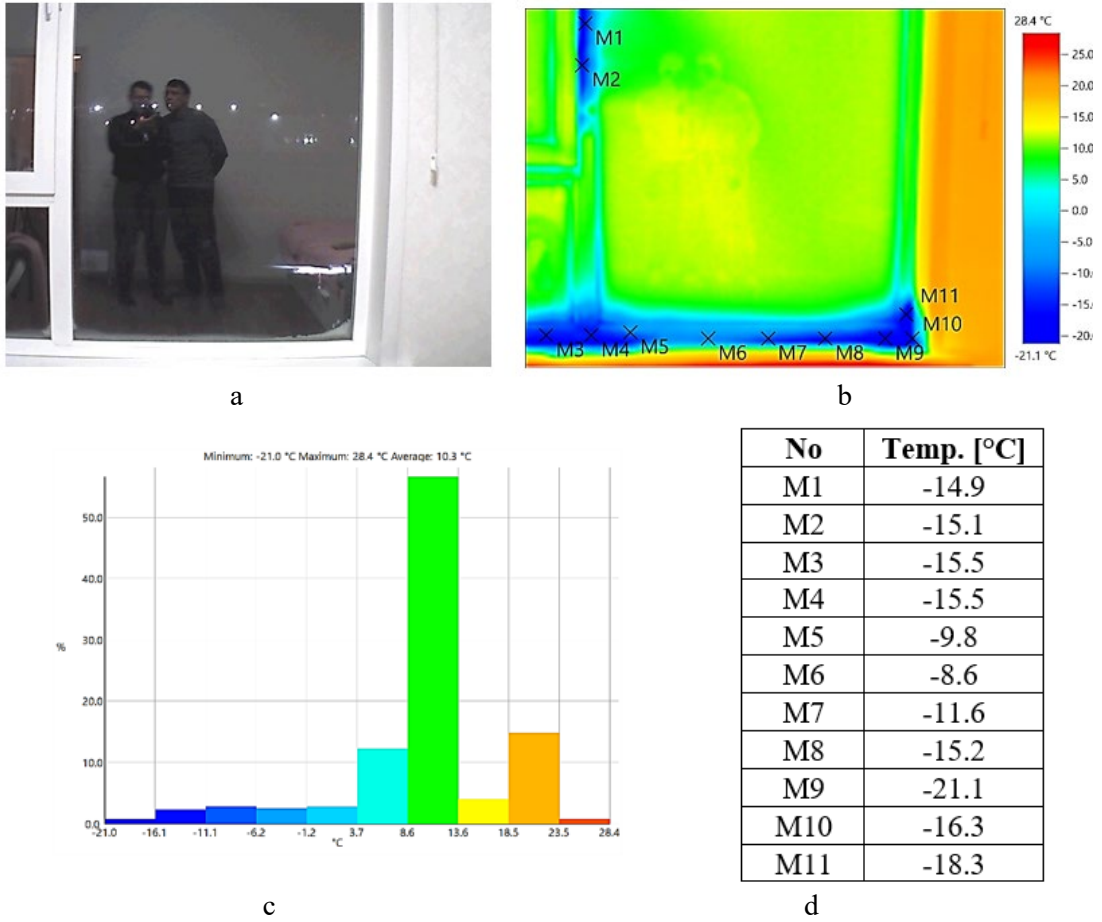
Fig. 19. A thermogram of the windowsill of external window in room No.1: a – in-place photo; b – thermogram with characteristic points; c – diagram of the area covered by the respective temperature; d – table of point values on the enclosure of Fig. b.

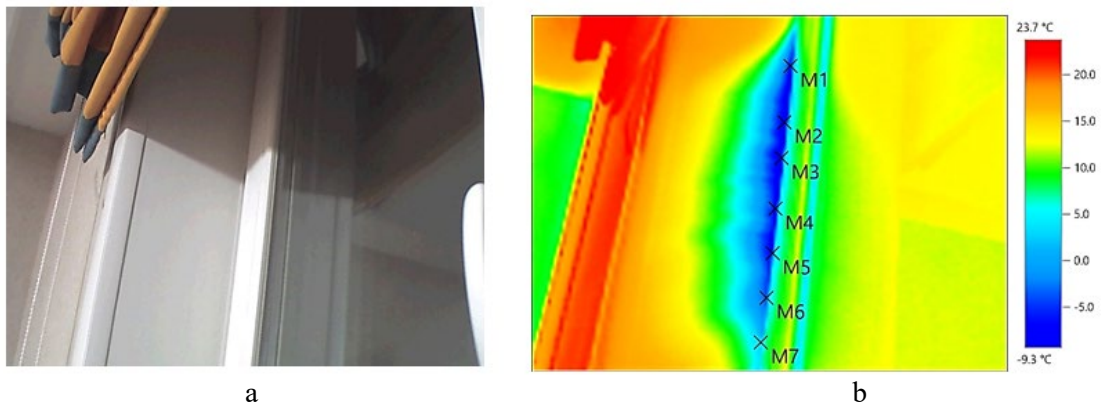
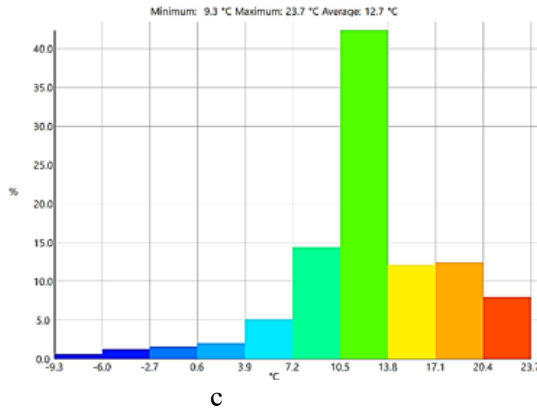
Fig. 20. A thermogram of the left vertical joint of external window in room No.2: a – in-place photo; b – thermogram with characteristic points; c – diagram of the area covered by the respective temperature; d – table of point values on the enclosure of Fig. b.

A similar problem with vulnerable locations was also detected in Room No.2 (Fig. 20 a). As per Fig. 20 (b) the minimum surface temperature at the left opening joint is -9.3 °C (Fig. 20 d), which is characteristic to point M3, and the total area of unfavorable temperature is 10.1 % (Fig. 20 c) of the total area of Fig. 20 (a, b). Survey of the window sill in this room also showed inadequate thermal protection (Fig.21a). The lowest temperature measured by the thermogram isotherm (Fig. 21 b) is equal to -9.3 °C, which is characteristic to point M1, where the unfavorable window sill area is 6.9 % of the total area of Fig. 21 (a, b). Study of the left external corner (Fig. 22a), where the reinforced concrete column is located, also shows the existence of a thermal protection problem. The isotherms on the thermogram of Figure 22 (b) on the surface of minimum temperature is equal to 6.5 °C, which is characteristic to point M5. The unfavorable area was 34.8 % of the total, Fig. 22 (a, b), which also does not meet the standard on thermal protection of buildings SP RK 2.04-107-2022.

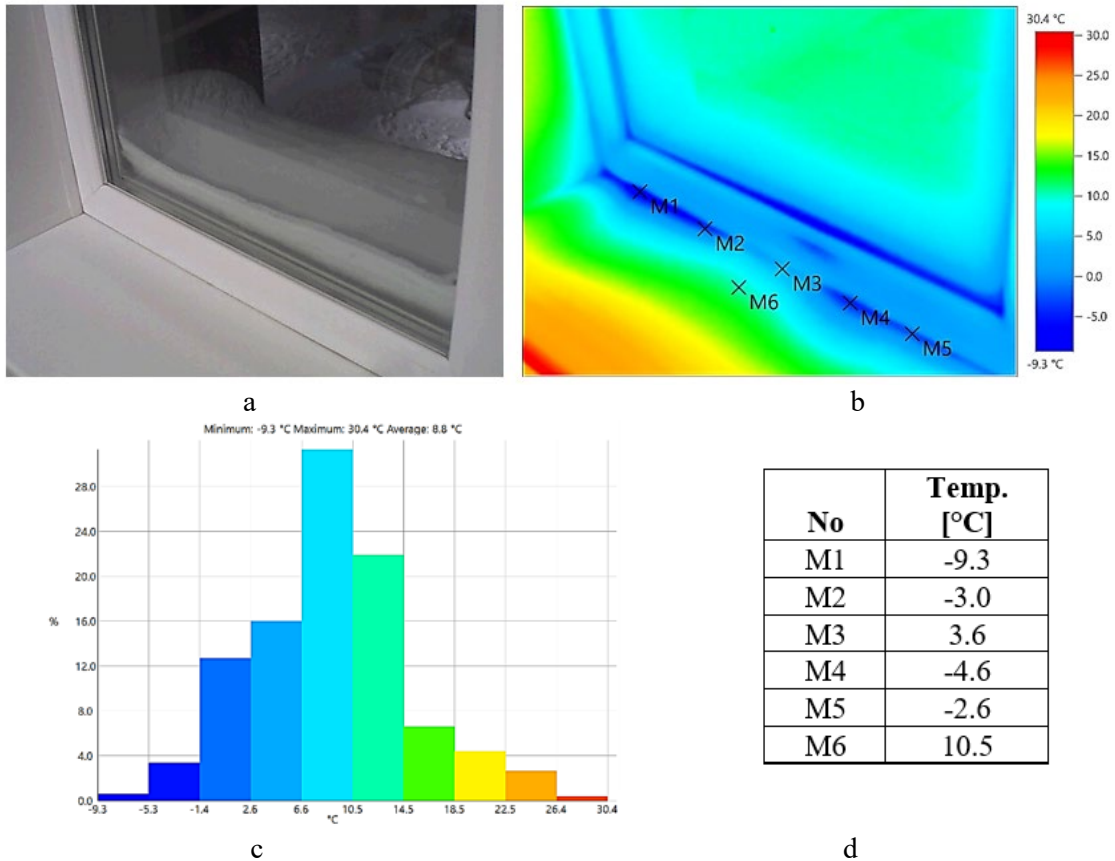
Fig. 21. A thermogram of the windowsill of external window in room No.2: a – in-place photo; b – thermogram with characteristic points; c – diagram of the area covered by the respective temperature; d – table of point values on the enclosure of Fig. b.

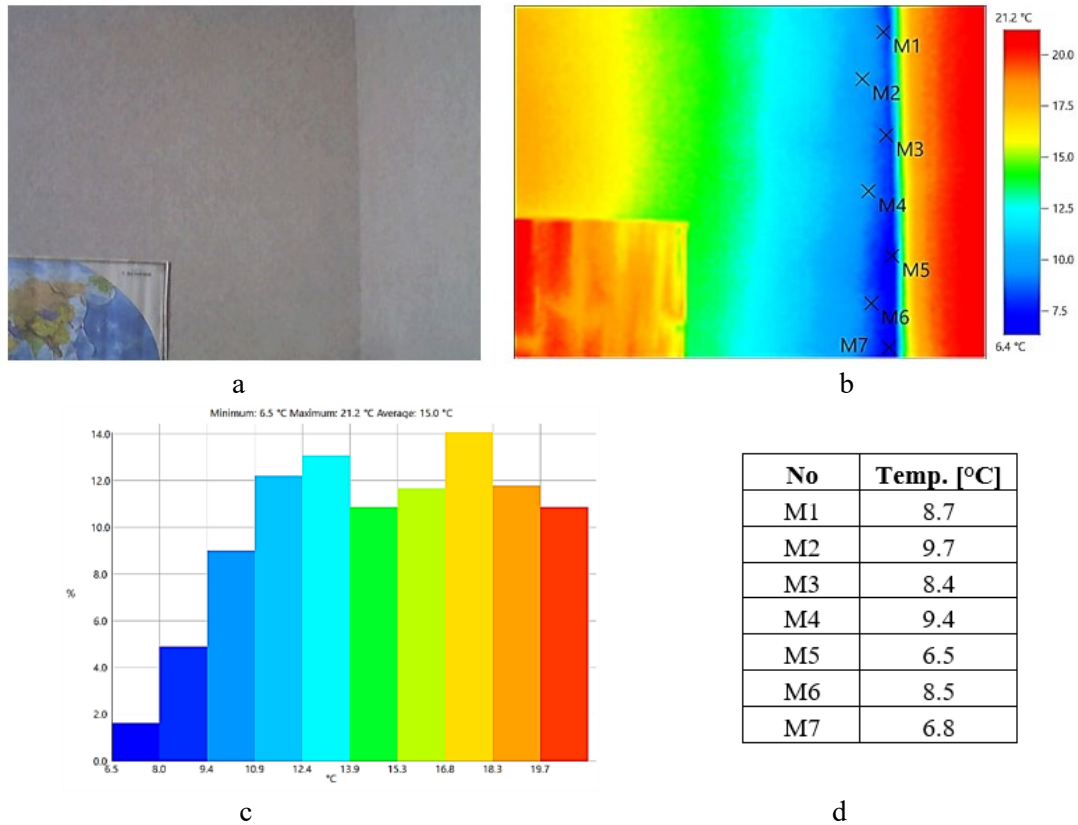
Fig. 22. A thermogram of the reinforced concrete column in room No.2: a – in-place photo; b – thermogram with characteristic points; c – diagram of the area covered by the respective temperature; d – table of point values on the enclosure of Fig. b.

5. An analysis of the thermograms of external corner, where the reinforced concrete column is located, showed that minimum temperature on the internal surface is 6.5 °C, and the area of the unfavorable zone is 34.8 % of the total, which also contradicts the standard on thermal protection of buildings.

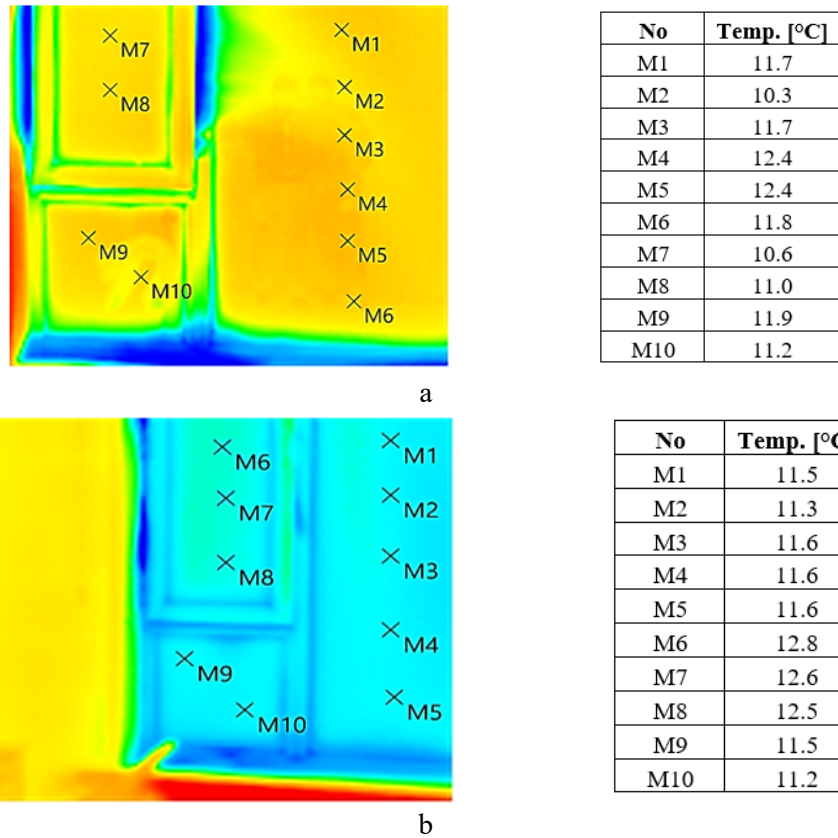
Fig. 23. Thermogram of the surface in the translucent aperture: a – room No.1; b – room No.2.

Survey of the translucent enclosure surface in the premises indicates that the design layout of a translucent enclosure, discussed in subsection 3.1.2 is accepted correctly. As, in accordance with the thermogram of Fig. 23 the average temperature of isotherm, Fig.23 (a) was 11.5 °C, and on the surface, Fig. 23 (b) the value of isotherm was 11.8 °C, which satisfies the condition $\tau_{int} > 3$ in the standard SP RK 2.04-107-2022. At the same time, survey of the internal surface of the upper floor slab showed (Fig. 24) that there are no heat losses through this surface, which can be explained by the selected design solution in the form of a warm attic, discussed in the subsection 3.1.3.

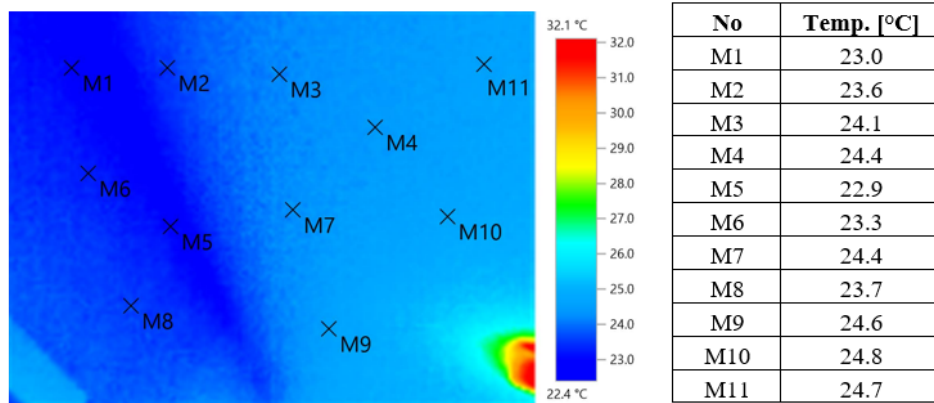
Fig. 24. Thermogram on internal surface of the upper floor slab.
