## Experimental determination of heat losses through cracks in building walls

**Abstract.** This study investigates how a repaired crack affects heat losses through a building envelope. An experimental setup was designed and assembled to test wall specimens containing a crack repaired by injection grout. A calculation procedure was developed to determine the specific heat loss through the repaired crack under the conditions of the proposed experimental apparatus. The experimental data were statistically processed using the Shapiro-Wilk test to assess normality. Differences in the specific heat loss before and after crack formation were evaluated with the paired Student's t-test. Statistical significance was accepted at  $p < 0.05$ . All statistical analyses were carried out in IBM SPSS Statistics. Tests were carried out on foam-concrete, clay brick, and reinforced concrete specimens. Ten specimens were prepared for each material under investigation. During the first stage, intact specimens without cracks were tested. Afterwards, an artificial crack was introduced into each specimen, repaired by injection grouting, and the specimens were tested again under identical conditions. The

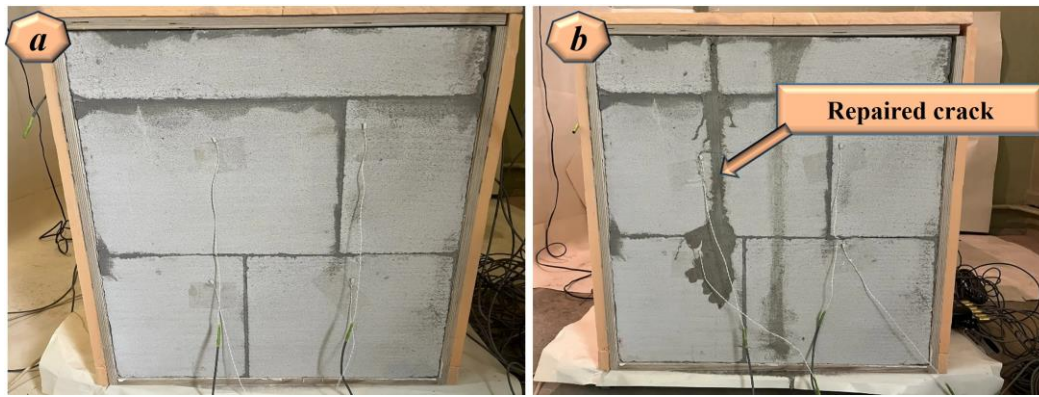
**Fig. 3.** Foam concrete specimens tested in the experimental apparatus: (a) intact specimen; (b) specimen containing a repaired crack.

The position of the repaired crack in Fig. 3b is indicated by an arrow.

Photographs of the tested foam-concrete specimens mounted in the experimental apparatus before and after crack repair are presented in Fig. 3.

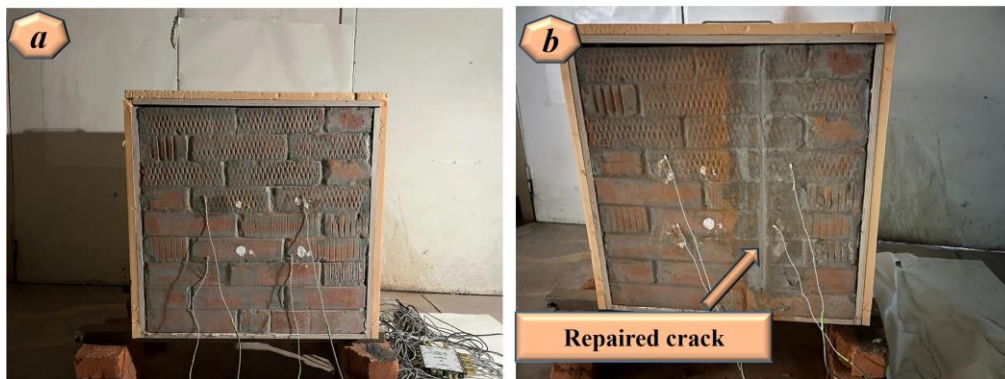
**Fig. 5.** Photographs of the specimens mounted in the developed test apparatus: (a) intact clay brick wall specimen; (b) clay brick wall specimen with an injection-repaired crack.
