Field thermovision study of external enclosure for multi-storey residential building under climatic conditions of Northern Kazakhstan

Abstract. An in-place thermovision study was carried out in a multi-apartment apartment building of high comfort in a cold period of the year, located in the Northern part of the Republic of Kazakhstan in the work. The study result showed the presence of significant problems on thermal protection at the edge and inner corner fences where the temperature difference between the inner surface of an enclosure and the internal temperature was 6.4 - 19.4°C. An analysis of thermograms of window joints in living rooms also showed a significant temperature drop from -9.3°C to 18°C, where total vulnerable area was up to 10%. Thermograms of window-sill joints of living rooms also showed a temperature drop to -21.1 °C with an area of 15.7 %. The temperature on a reinforced concrete column's inner surface showed a value of 6.5 °C, which is typical for an area of 34.8 %. An analysis of outside and inside temperatures showed that as the temperature drops from -7 °C to -23 °C during the day, the inside temperature of the room remains relatively stable at 25.3 - 26.

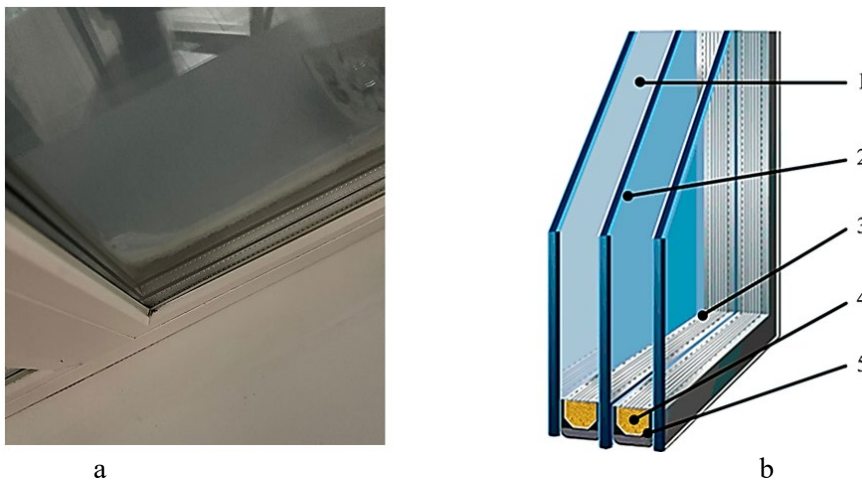
Fig. 4. Translucent window aperture: a – view of a in-place window; b – name of the translucent window aperture construction: 1-air chamber, 2-glass sheet, 3-distance frame, 4-molecular sieve, 5-sealant.

A translucent construction was selected as per norm SP RK 2.04-107-2022, where in accordance with a calculation method the heat transfer resistance R_s of translucent constructions is determined on the basis of SN RK 2.04.04-2011. Here, first of all, the heating season degree-days (HSDD) indicator was calculated and the value R_s was determined based on it, and the design selection was carried out by value of the reduced heat transmission resistance R_d . Thus, the design of a translucent aperture chosen at the design stage meets the condition $R_d \geq R_s$.
